## Structural Integrity Reserve Study Report

**Bayview Condominiums Clearwater Association, Inc.**

700 North Osceola Avenue, Clearwater, FL, 33755

December 2024

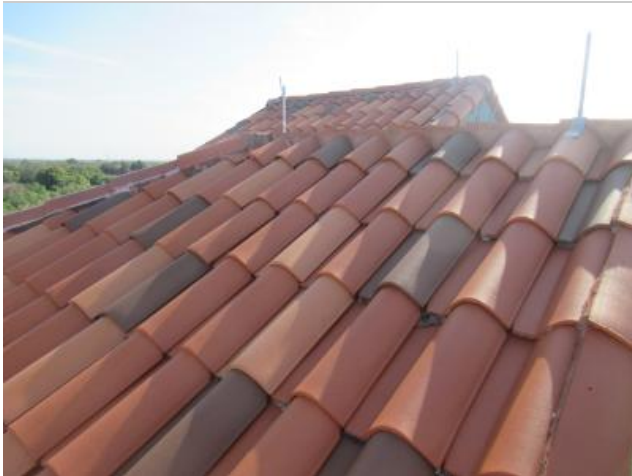
### 1 - Clay Tile Roof

Type of Cost:	Replacement
Category:	Roofing
Location:	Roof
Regulatory:	SIRS
Condition:	Fair

Portions of the building roofs consist of a clay tile system. This type of roof system typically has a useful life of 25-years under normal operating conditions with routine yearly maintenance. We have included a reserve item for replacement of the tile roof system.

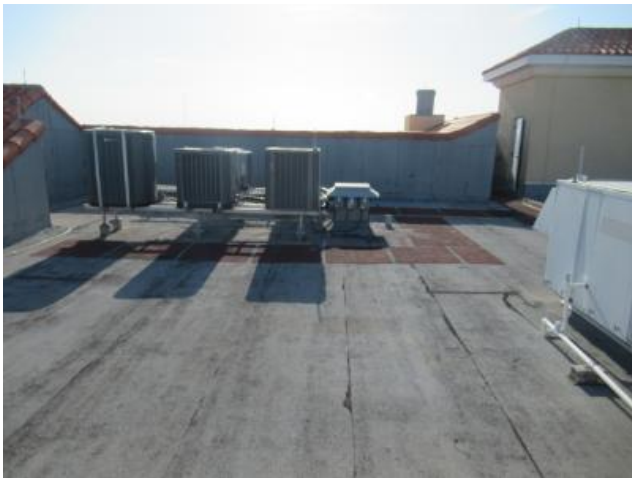
## 2 - Flat Roof - Modified Bitumen

Type of Cost:	Replacement
Category:	Roofing
Location:	Roof
Regulatory:	SIRS
Condition:	Fair

The flat roof of the building consists of a modified bitumen roof system. This type of roof system typically has a useful life of 20 to 25 years under normal operating conditions with routine yearly maintenance. At the time of our site visit, the modified bitumen roof was observed to be in fair condition. We have included a reserve item for replacement of the roof.

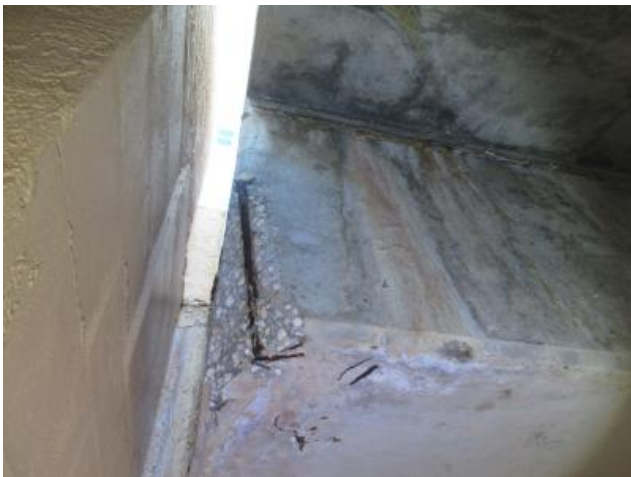
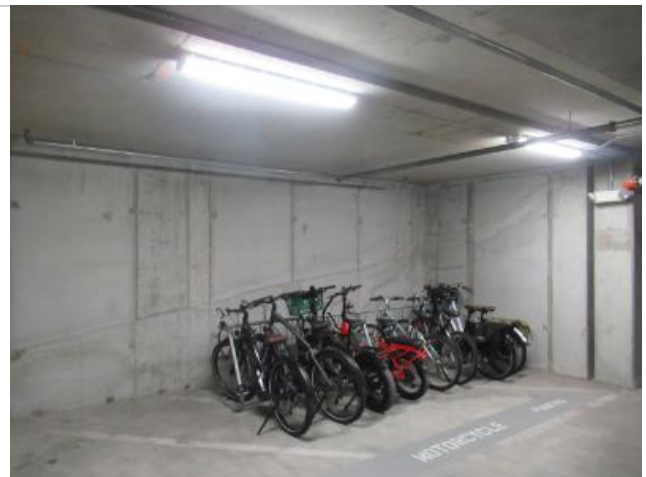
# 3 - Concrete and CMU Repairs

Type of Cost:	Repairs & Maintenance
Category:	Load Bearing Structural Members
Location:	Entire Building
Regulatory:	SIRS
Condition:	Fair

The load bearing structural members include reinforced concrete decks supported by concrete beams, columns, and shear walls. Exterior walls consist of stucco covered masonry block in-fill. These types of primary structural members typically have a useful life of 100 or more years when properly maintained/repared. However, during the life of this type of structure it is common for periodic maintenance to be required to correct localized deterioration. We have included a reserve item for completing required periodic maintenance to the structural elements.

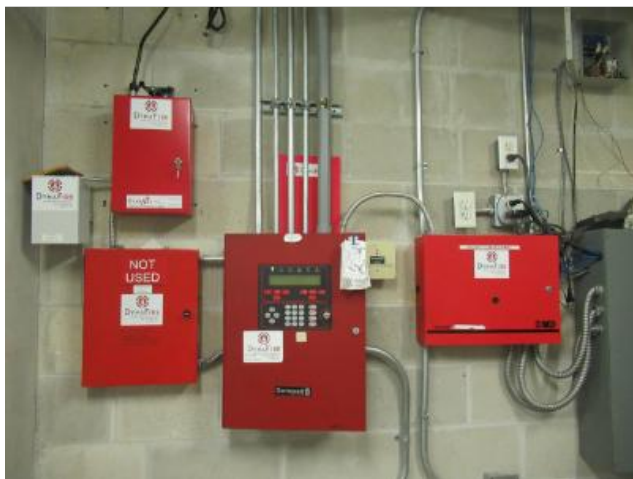
# 4 - FACP and Audio-Visual Fire Alarm System

The main fire alarm control panel (FACP) for the condominium is located on the G-2 garage level. Numerous audio-visual alarms, fire extinguishers, and fire alarm pull switches are located throughout the building. Typically, these control systems have a useful life of 25 to 30 years before requiring an updated system. We understand the FACP is original to the structure. When replacing a fire control panel, an update to other various control boxes and audio-visual alarms may be required. Periodic inspections are also required for various FACP and audio-visual fire alarm components and sprinklers. Therefore, the reserve has been included for replacement of the FACP and portions of the related equipment.

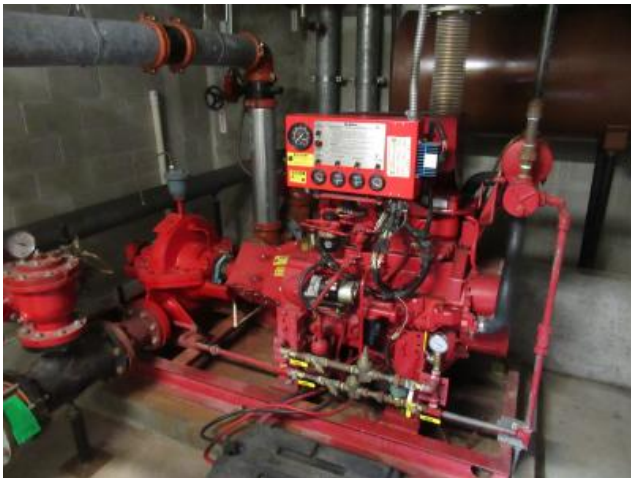
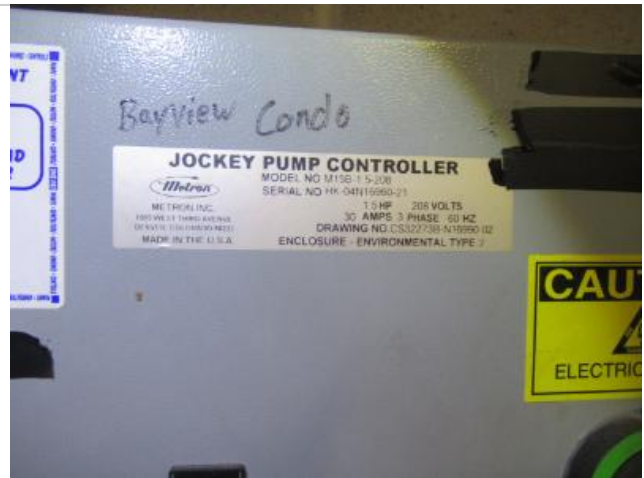
# 5 - Fire Pump and Controls

Type of Cost: Replacement  
Category: Fireproofing and Fire Protection Systems  
Location: Entire Building  
Regulatory: SIRS  
Condition: Fair

The diesel fire pump, fire pump controller, and 1.5 hp jockey pump and controller are located on the G-2 garage level. Typically, fire pump systems have a useful life of approximately 45 years before requiring a major update or replacement. We understand the fire pump is an original component to the structure. A reserve has been included for major upgrades and/or replacement of the fire pump system.

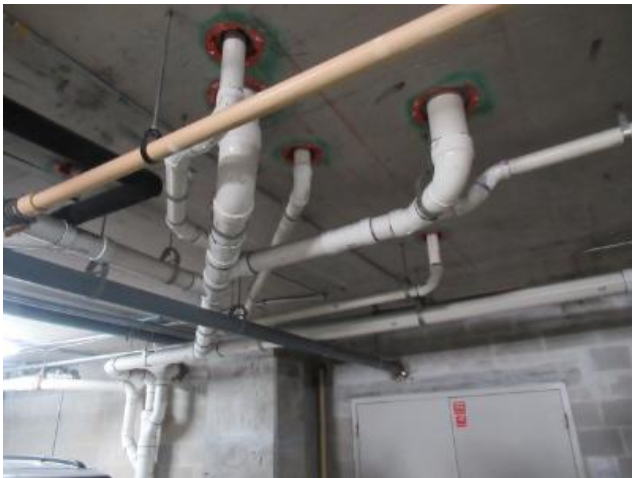
# 6 - Plumbing Repairs

Our observations indicate that the sanitary lines consist of polyvinyl chloride (PVC) pipe. PVC lines of this nature typically can last up to 70 to 100-plus years with routine maintenance. Normal replacement or repair of PVC sanitary lines is accomplished on an as-needed basis. Lateral sanitary plumbing lines are normally unit owner responsibility components. They are typically replaced by the unit owner during a unit renovation under a permitted renovation. We have included a reserve to address periodic repairs to the plumbing components.

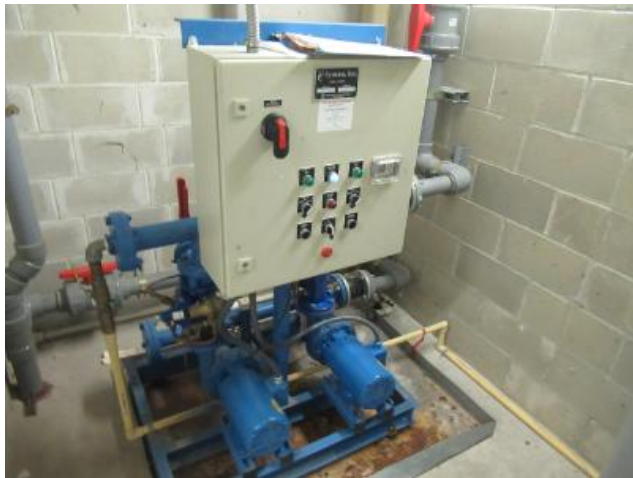
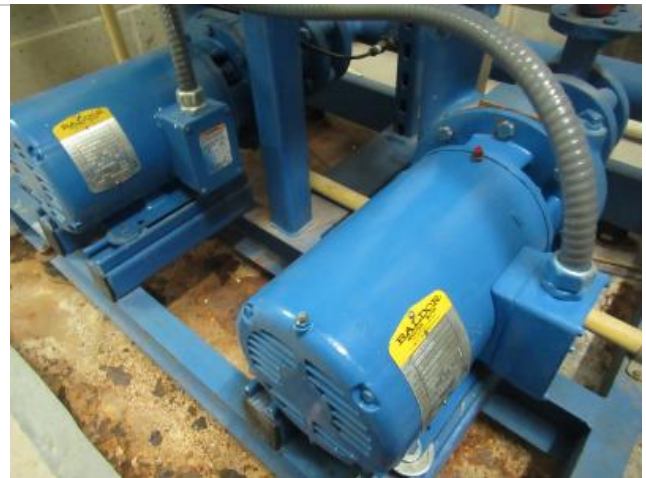
# 7 - Domestic Booster Pumps

The subject condominium includes two 3 hp domestic water pumps. The domestic water pumps, pump controller, and other related equipment are located on level G-2. We understand the domestic water pump system has been repaired throughout the years. A reserve has been included for replacement of the domestic water pumps and their related equipment.

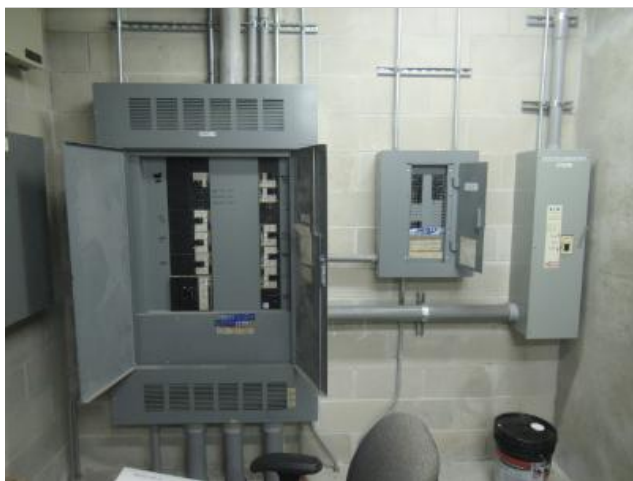
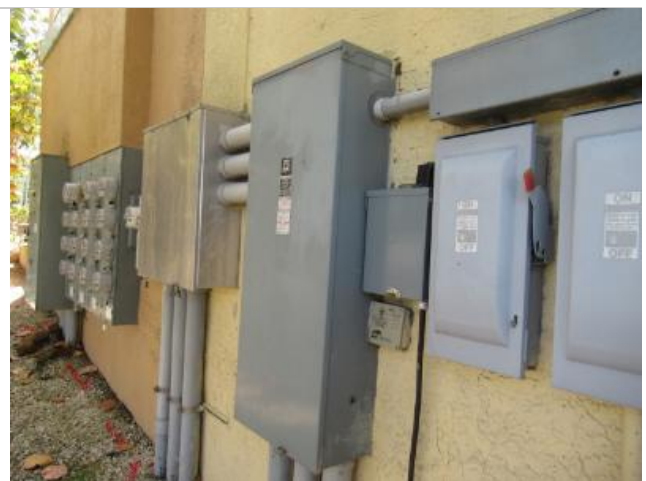
# 8 - Electric System Upgrade

Currently there are no indications of any deterioration or issues with the common area electrical system for the subject condominium. The main electrical equipment (disconnects, breakers, panels, switches) is located in a level G-2 electrical room and on the exterior of the structure. Localized breaker panels are in each unit. Localized breaker panels and branch circuits are typically replaced during common area or individual unit renovations as required to accommodate the renovation. A reserve has been included for periodic replacement/upgrades of major electrical system components such as main service panels and feeder lines.

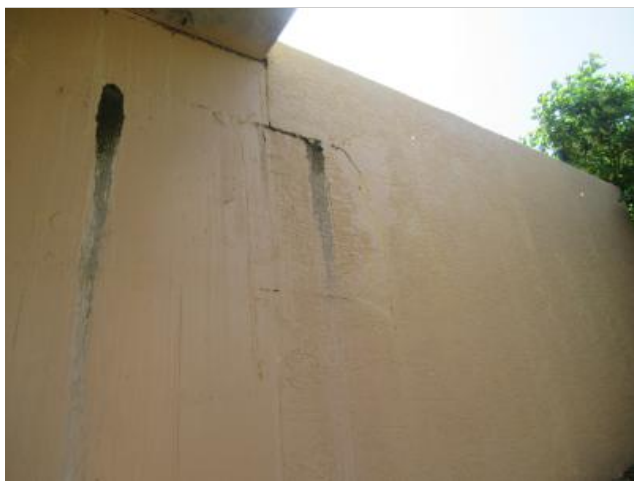
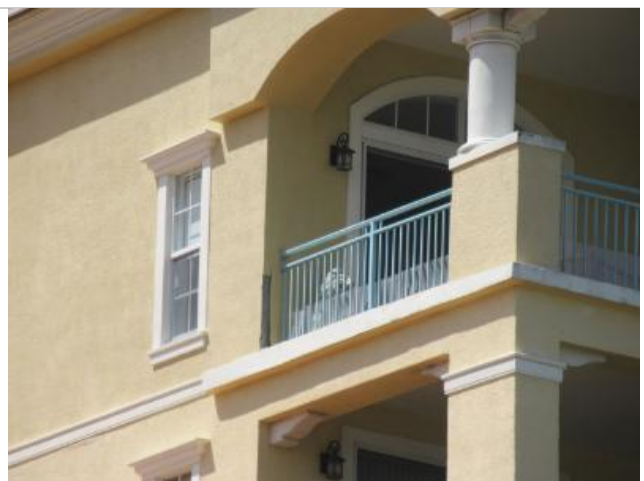
# 9 - Exterior Painting and Restoration

Type of Cost:	Replacement
Category:	Waterproofing and Exterior Painting
Location:	Entire Building
Regulatory:	SIRS
Condition:	Fair to Poor

We understand the subject building's exterior surfaces were last recoated in 2014. For buildings located in the southwest Florida region, we typically recommend the exteriors be recoated on a 7 to 10-year basis. As noted in this report, the structure's paint is in fair to poor condition and in need of replacement. It is understood that due to a 2025 ongoing construction project neighboring the property, we are providing an extended initial useful life to paint the building in 2026. A reserve has been included for periodic recoating of the building's exterior on no more than a 10-year paint cycle thereafter.

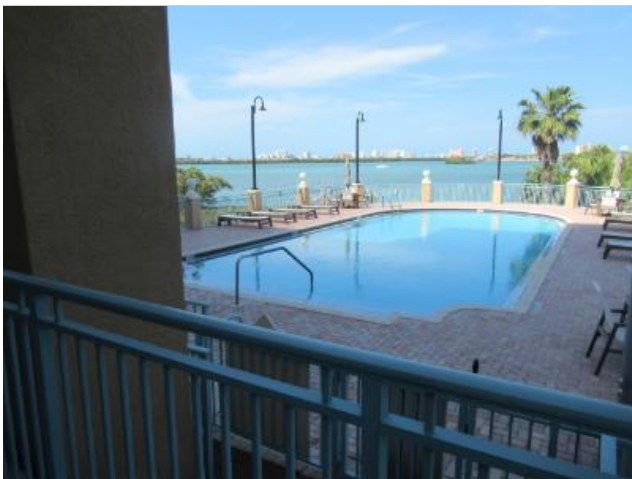
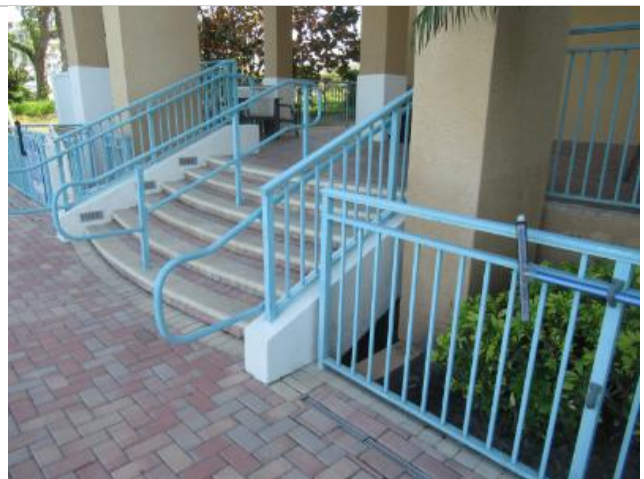
# 11 - Pool Deck Waterproofing

The horizontal surfaces of the elevated pool deck are concrete decks covered with concrete pavers. It is assumed the elevated pool deck was last waterproofed circa 2004. Typical waterproofing systems have useful lives of 20 to 25 years dependent upon the system and exposure. Exterior horizontal concrete decks should be waterproofed to protect the concrete structure from deterioration. A reserve has been included for periodic application or replacement of the waterproofing membrane.

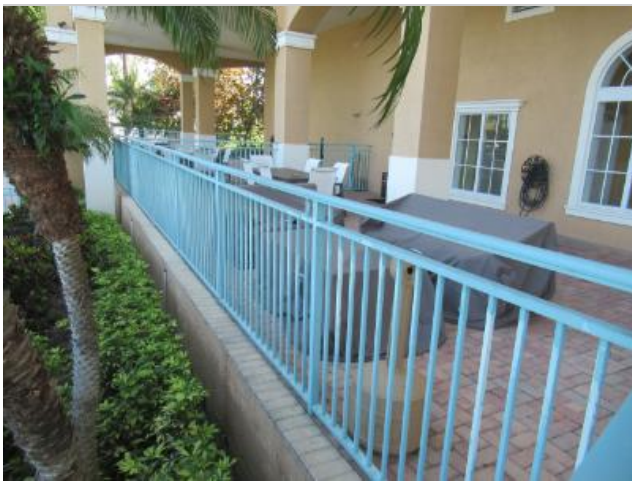
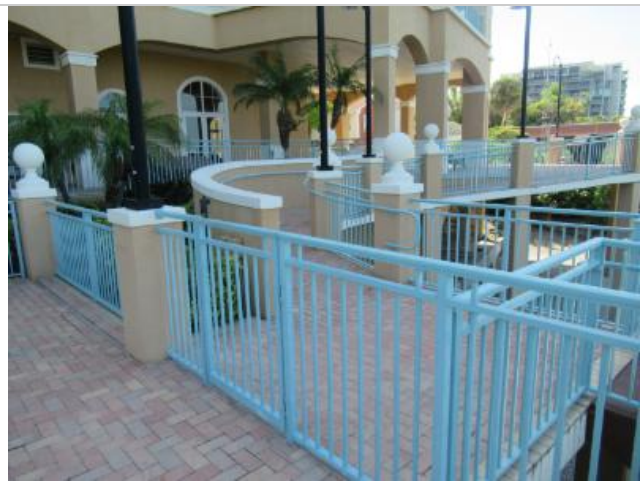
# 12 - Planter Box Waterproofing

Elevated planter boxes are located at the pool deck area of the structure. We understand they were last waterproofed circa 2004. A reserve has been included for the replacement of the waterproofing systems of the planter boxes.

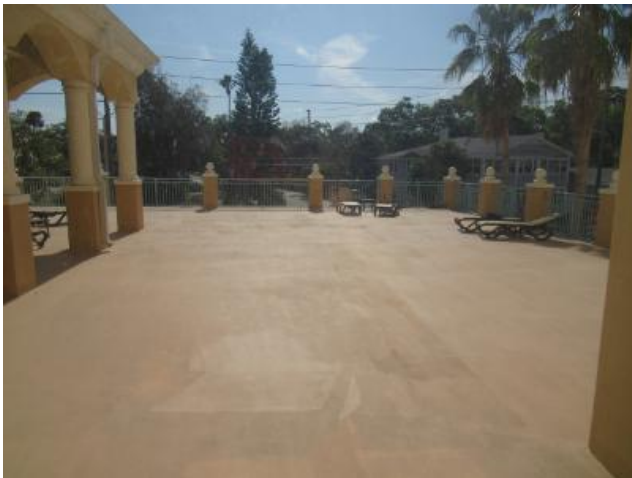
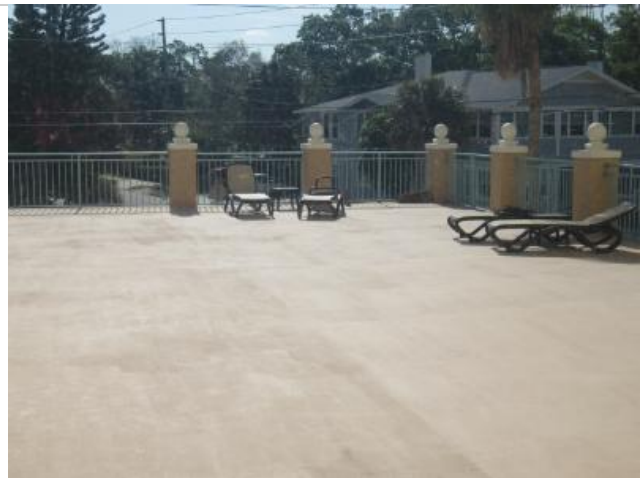
# 13 - Recreation Deck Waterproofing

It is our understanding the Association is responsible for waterproofing the recreation deck that is located near the fitness room on the east side of the structure. We further understand the deck was last waterproofed in 2022. Typical waterproofing systems have useful lives of 10 to 15 years dependent upon the system and exposure. Exterior horizontal concrete decks should be waterproofed to protect the concrete structure from deterioration. A reserve has been included for periodic application or replacement of the waterproofing membrane.

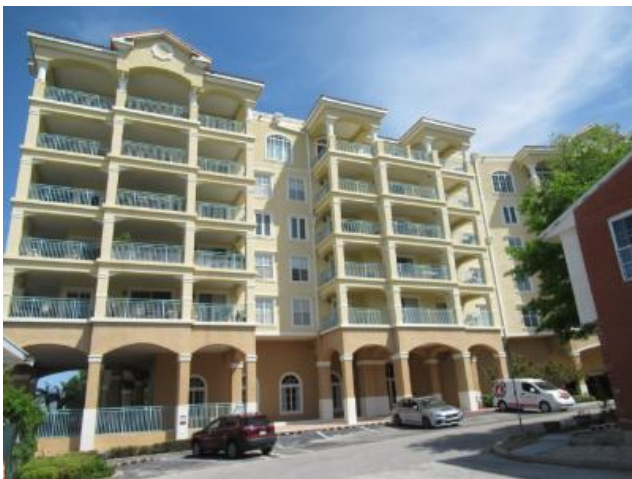
# 14 - Balcony Waterproofing

It is our understanding the Association is responsible for waterproofing the elevated horizontal decks at the unit balconies. We further understand the unit balconies were last waterproofed circa 2004. Typical waterproofing systems have useful lives of 10 to 15 years dependent upon the system and exposure. Exterior horizontal concrete decks should be waterproofed to protect the concrete structure from deterioration. It is understood that due to a 2025 ongoing construction project neighboring the property, we are providing an extended initial useful life to waterproof balconies in 2026. A reserve has been included for periodic application or replacement of the waterproofing membrane on no more than a 15-year cycle thereafter.

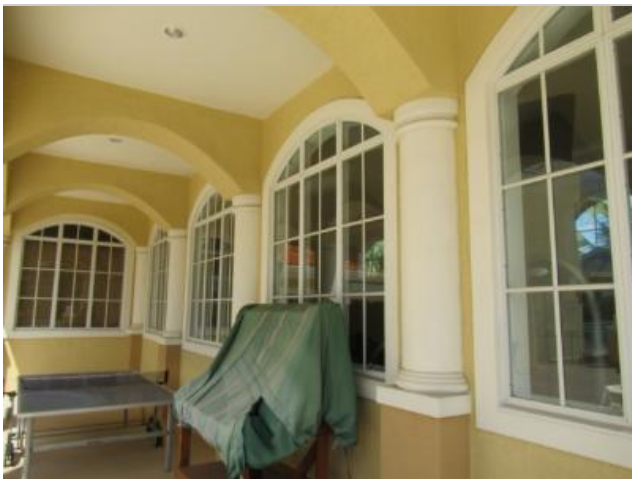
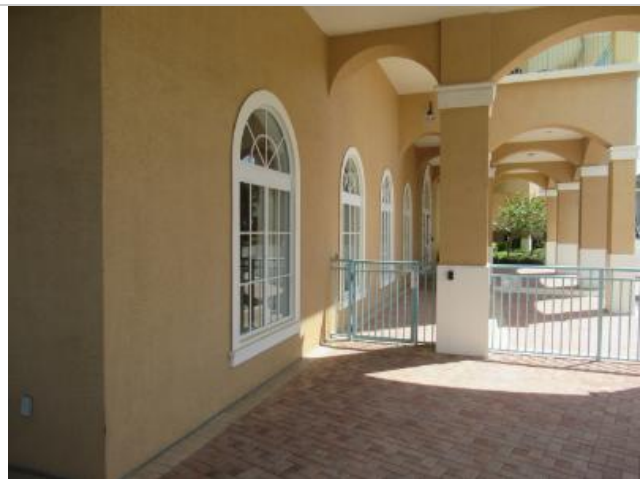
Type of Cost:	Replacement
Category:	Windows and Doors
Location:	Entire Building
Regulatory:	SIRS
Condition:	Good to Fair

It is our understanding the Association is responsible for the common windows located on the lobby level and near the fitness room. We further understand these windows are original components of the structure. We have provided a reserve allowance to maintain/replace the windows on an as needed basis.

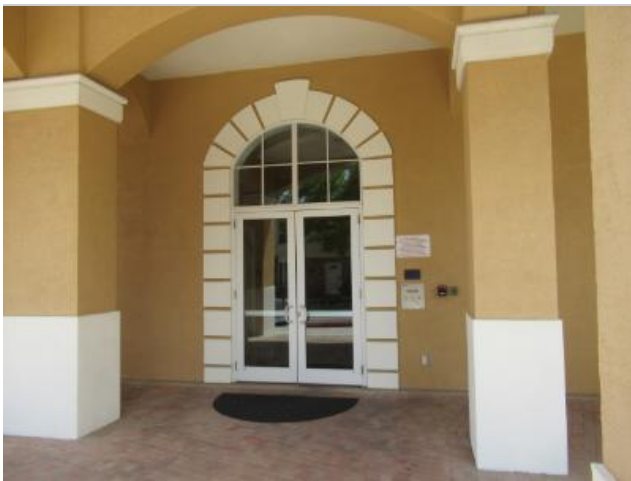
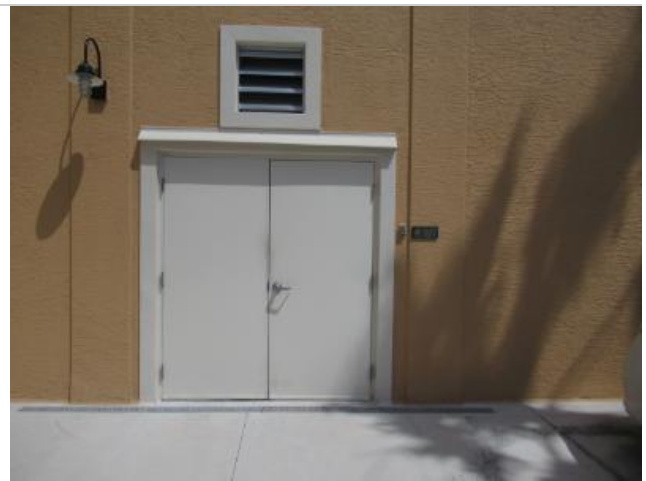
# 16 - Common Exterior Doors

Type of Cost:	Replacement
Category:	Windows and Doors
Location:	Entire Building
Regulatory:	SIRS
Condition:	Good to Fair

It is our understanding the Association is responsible for the common doors located throughout the structure. We have provided a reserve allowance to maintain/replace the doors on an as needed basis.
