# Windstorm Mitigation Affidavit Report

Bayview Condominiums Clearwater  
700 N Osceola Ave, Units 301-606, PH 1-4  
Clearwater, FL 33755

Prepared Exclusively for Bayview Condominiums Clearwater Association, Inc.  
As of 06-23-2026 | FPAT File# MUD2627244

# Uniform Mitigation Verification Inspection Form

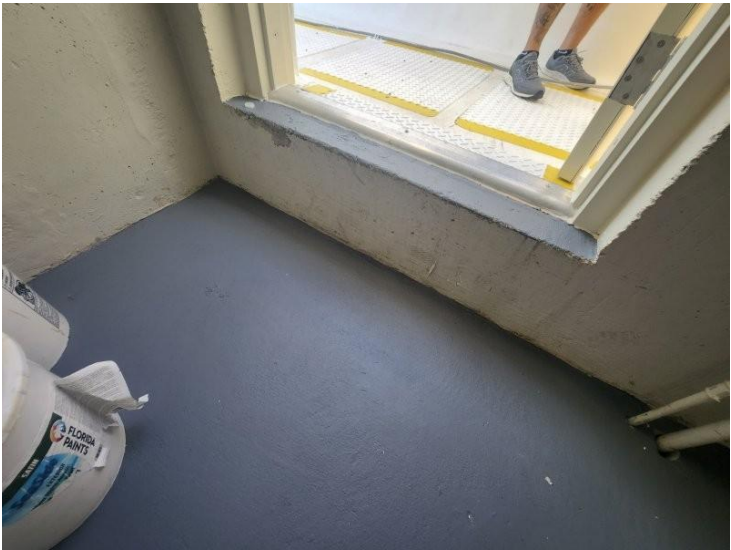
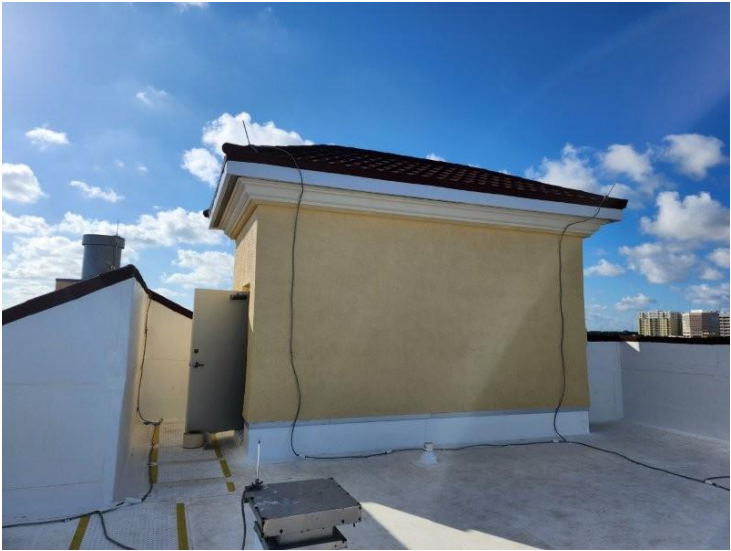
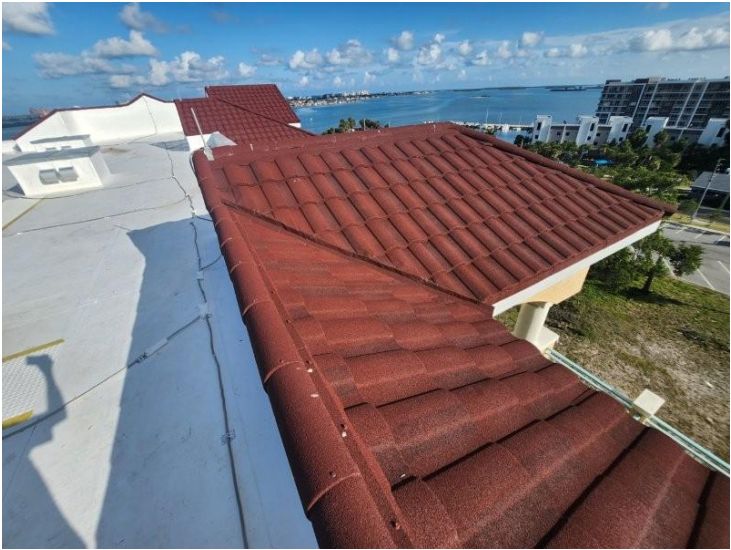
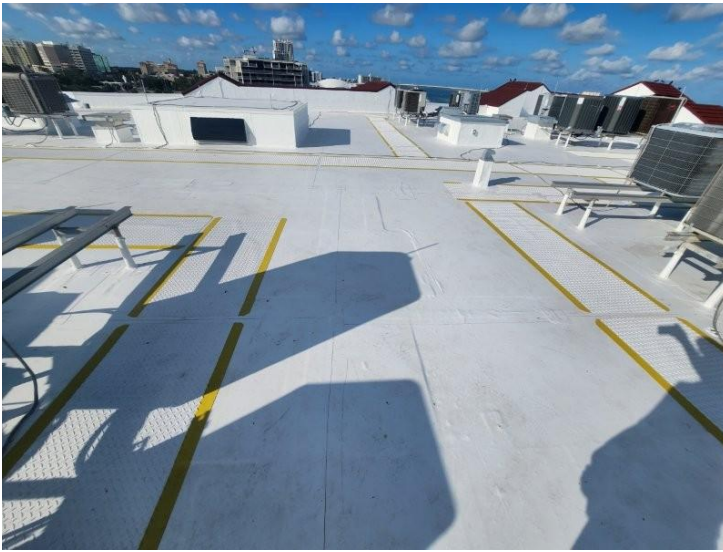
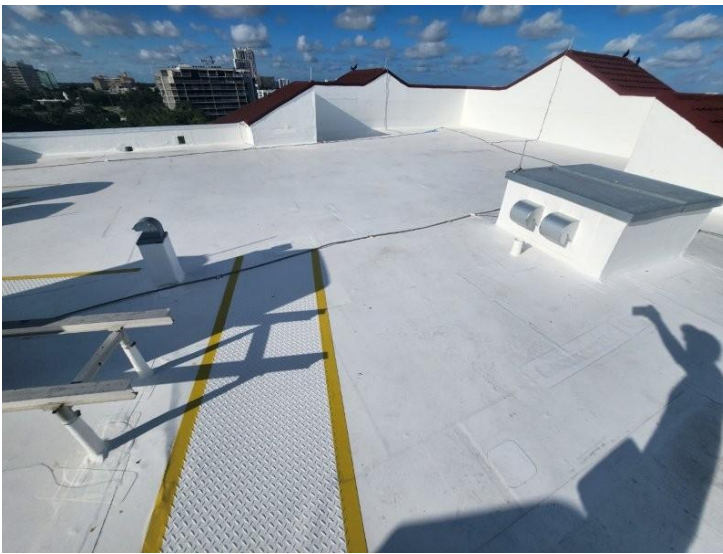
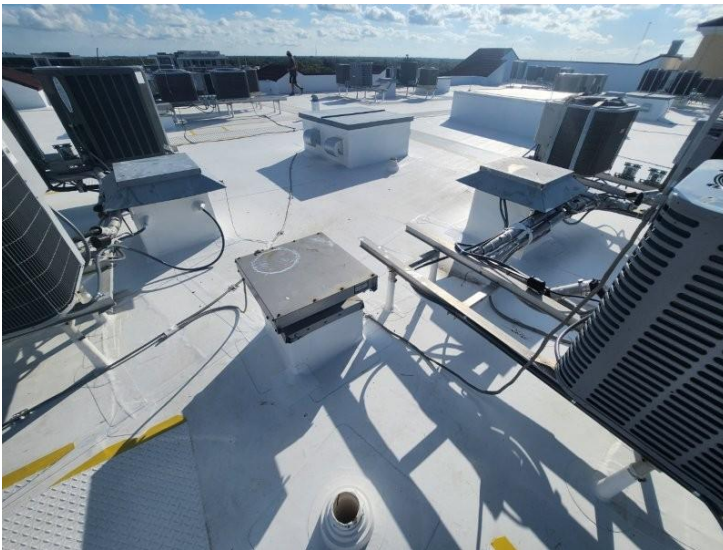
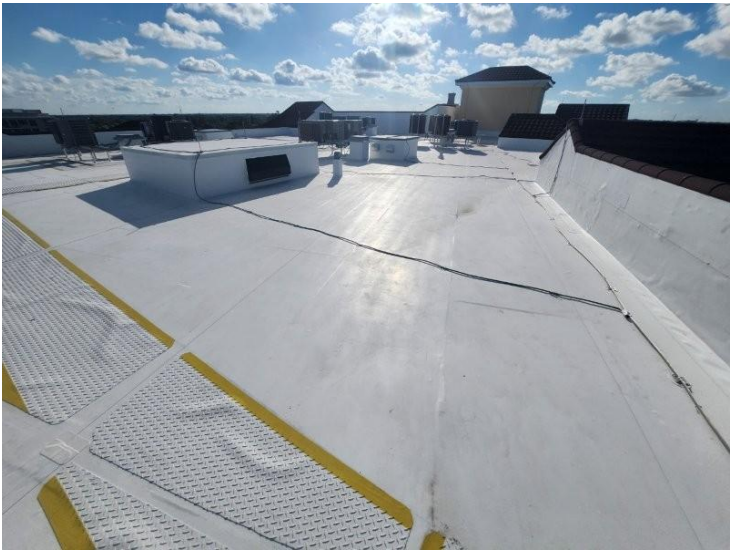
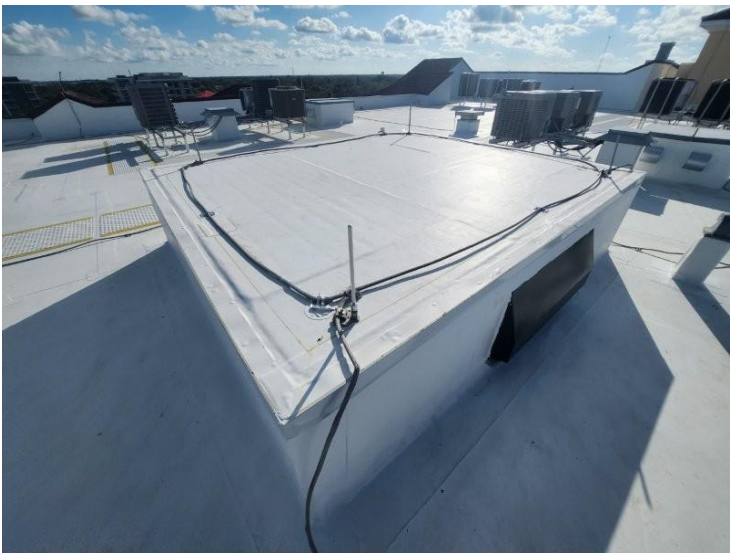
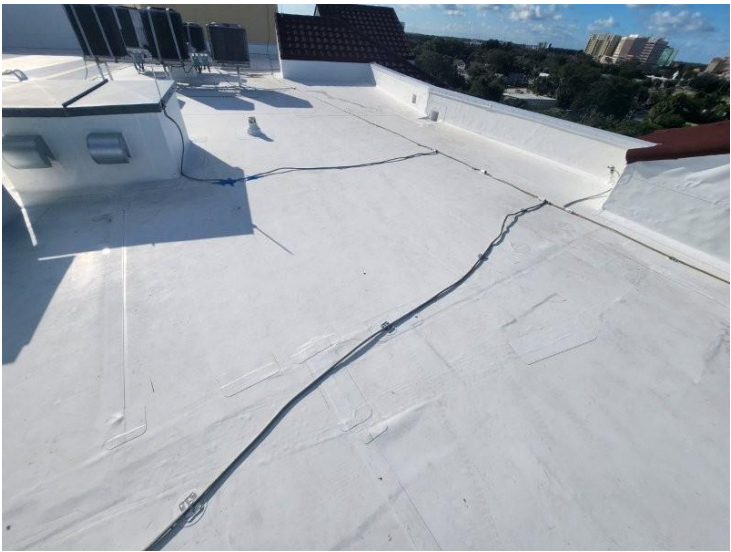
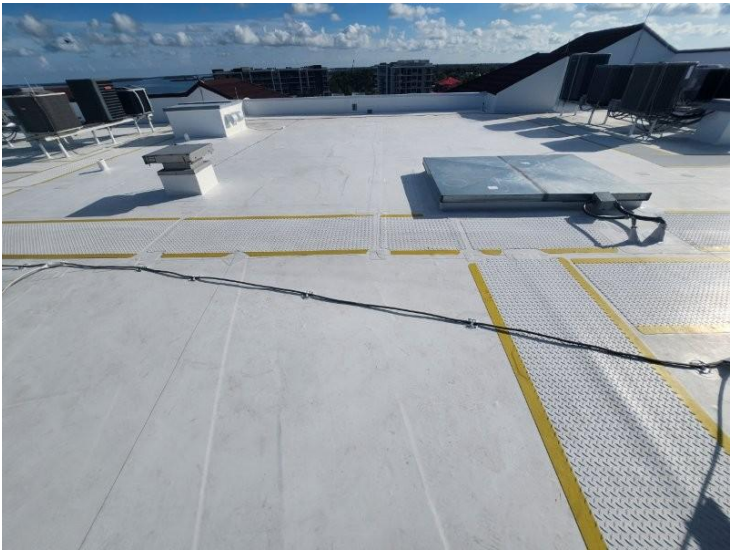
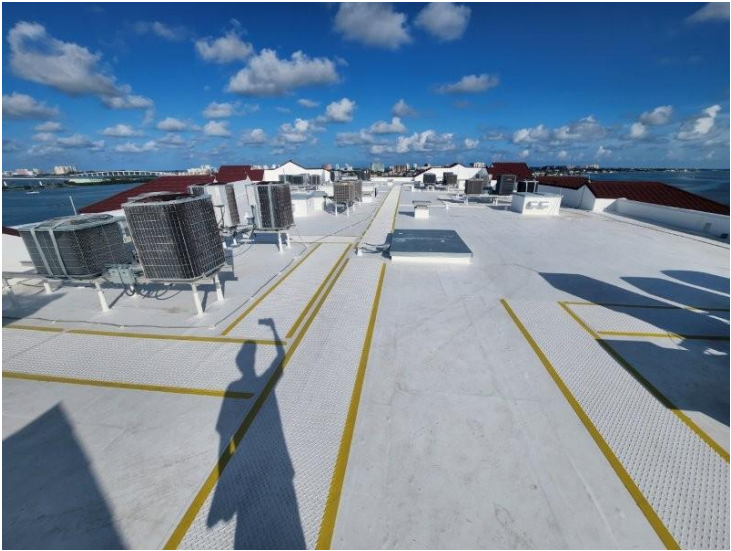
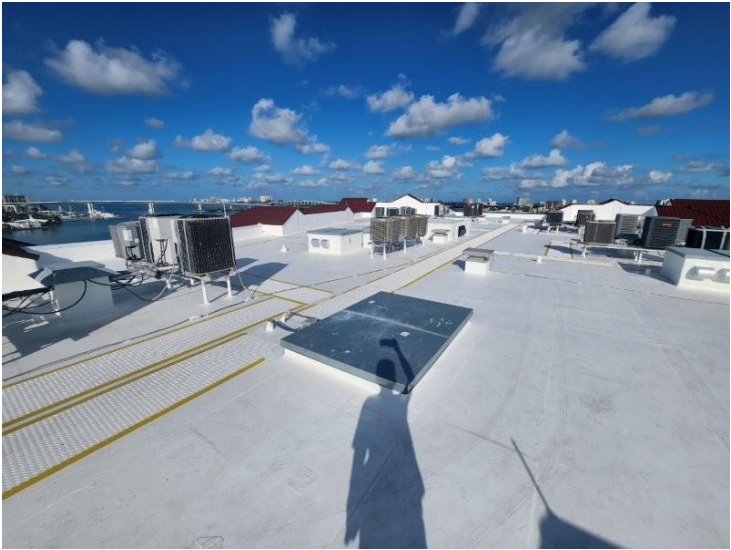
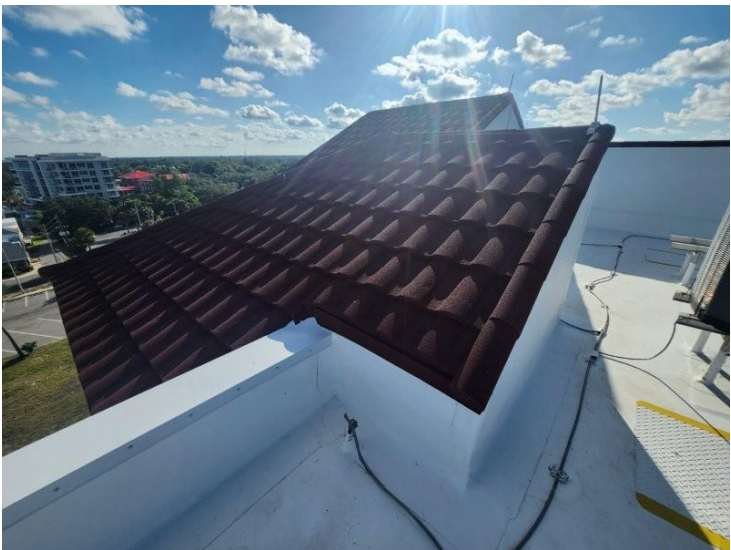
Roof Construction

| <b>5. Roof Deck Attachment:</b><br>Comments: | <b>D. Reinforced Concrete Roof Deck</b><br>Inspection verified a roof structure composed of cast-in-place or pre-cast structural concrete designed to be self-supporting and integrally attached to the wall / support system. |
| <b>6. Roof to Wall Attachment:</b><br>Comments: | <b>E. Structural</b><br>Inspection verified a roof structure composed of cast-in-place or pre-cast structural concrete designed to be self-supporting and integrally attached to the wall / support system. |
| <b>7. Roof Geometry:</b><br>Comments: | <b>B. Flat Roof</b><br>Inspection verified flat roof shape, refer to attached photographs. |

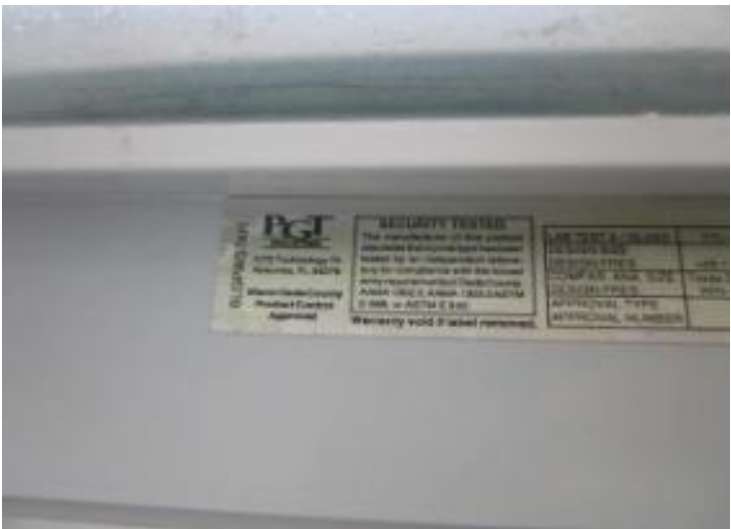
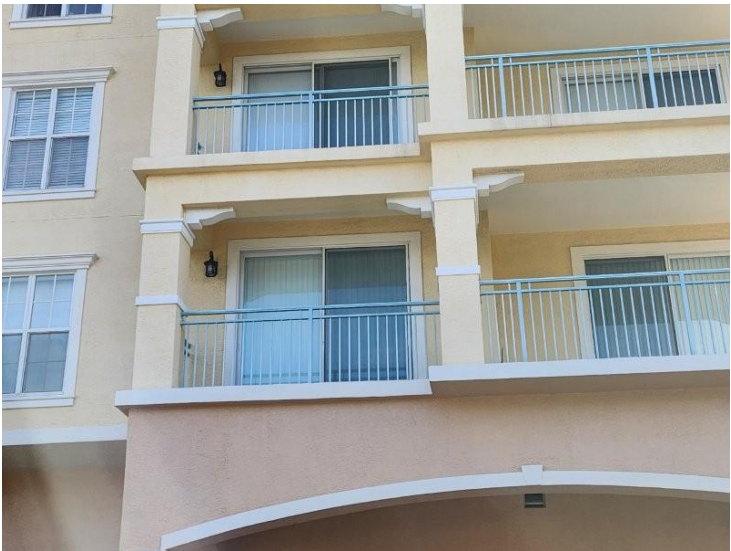
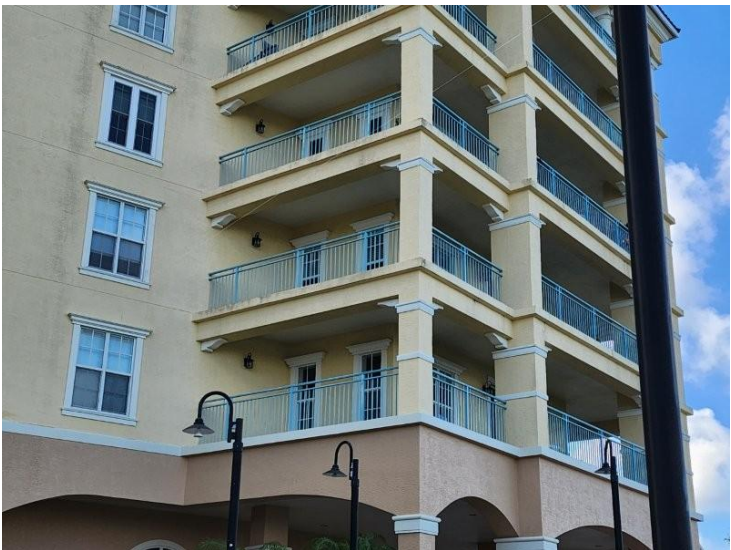
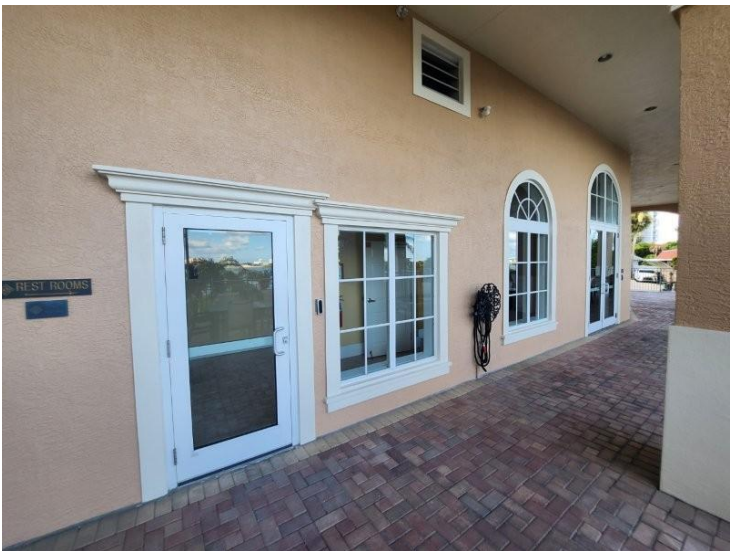
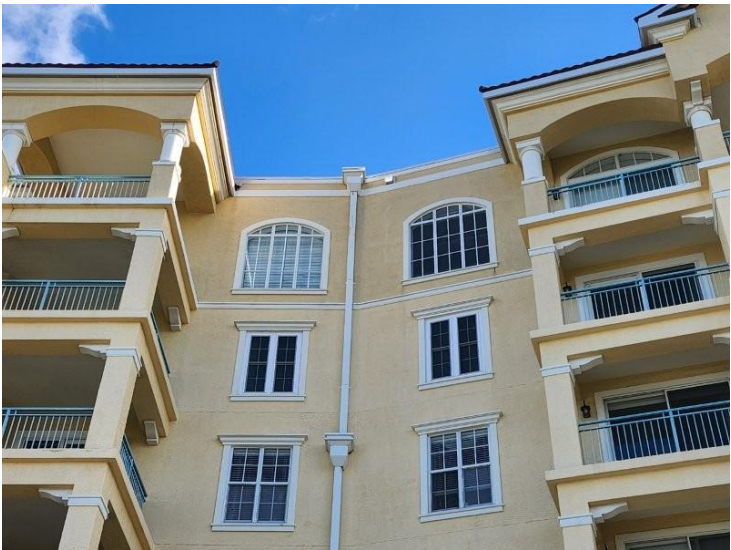
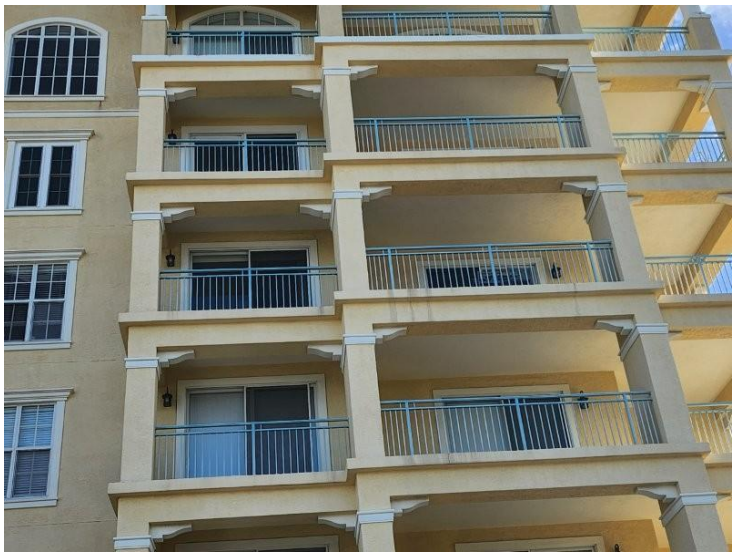
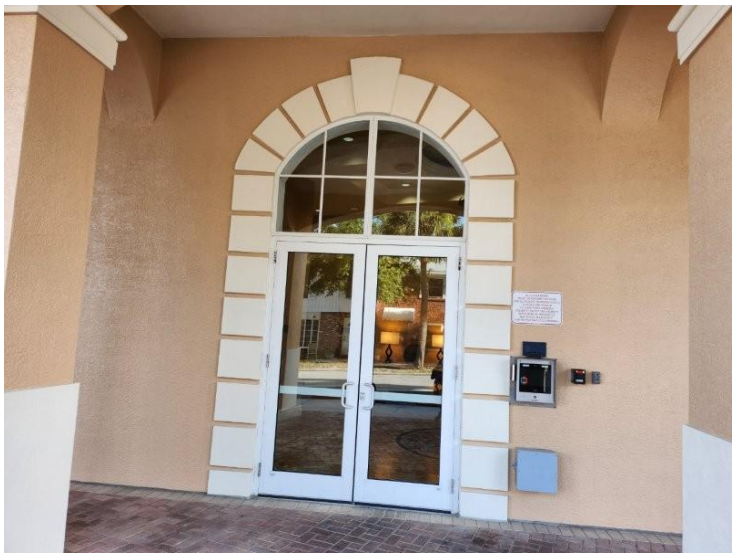
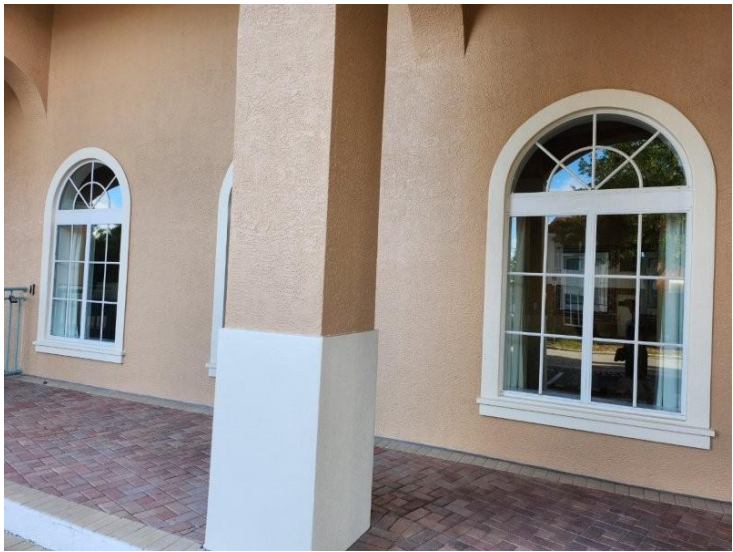
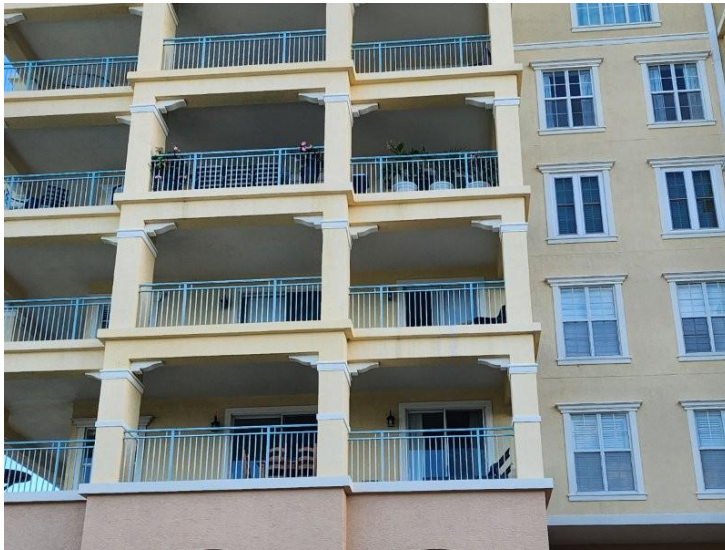
Opening Protection

| <b>9. Opening Protection:</b><br>Comments: | <b>X. None or Some Glazed Openings</b><br>Inspection verified some windows and sliding glass doors are protected with large missile rated glazing. Not all glazed opening could be verified as large missile impact rated. |
